ISS Inspection Capabilities and Challenges

NASA Johnson Space Center
Astromaterials Research and Exploration Science (ARES)
Image Science and Analysis Group (ISAG)
KX/Randy Moore
<http://isag.jsc.nasa.gov/>

July 2014

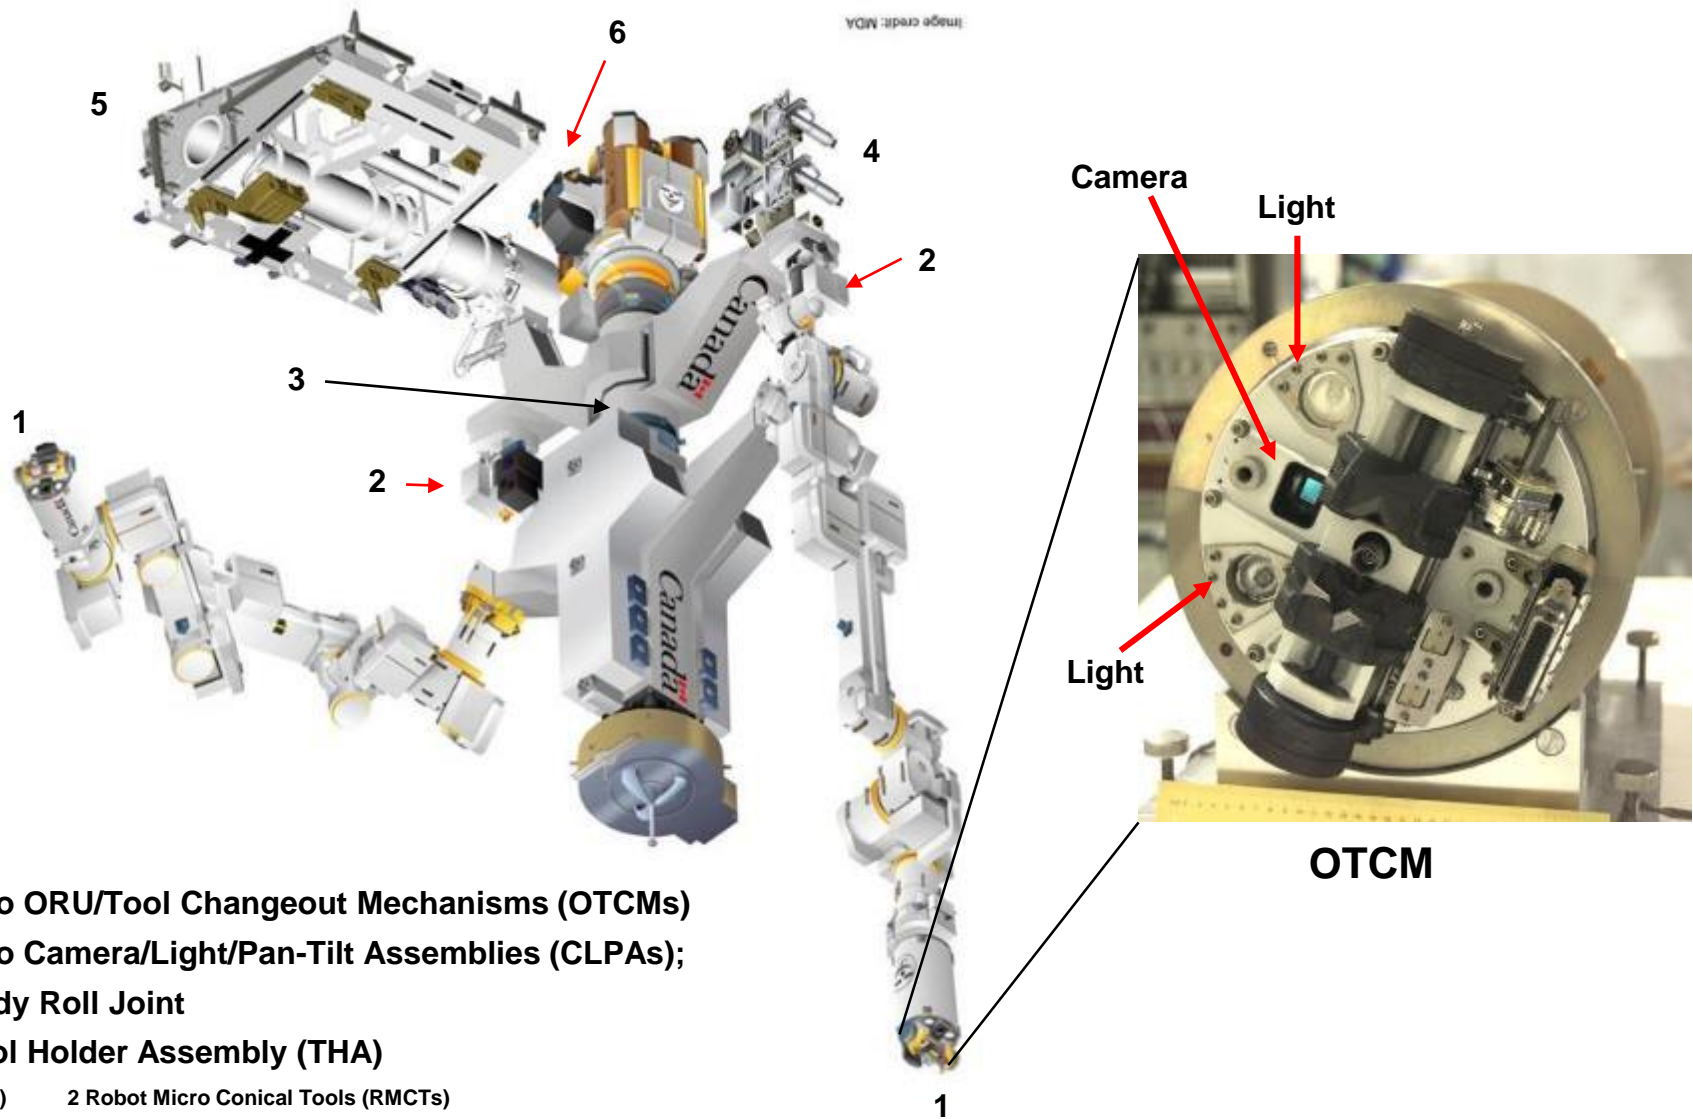
SPDM (DEXTRE) Overview

1. Two ORU/Tool Changeout Mechanisms (OTCMs)
2. Two Camera/Light/Pan-Tilt Assemblies (CLPAs);
3. Body Roll Joint
4. Tool Holder Assembly (THA)
 - a) 2 Robot Micro Conical Tools (RMCTs)
 - b) Socket Extension Tool (SET)
 - c) Robotic Offset Tool (ROST)
5. Enhanced ORU Temporary Platform (EOTP)
6. SPDM Latching End Effector (LEE) with Camera/Light Assembly (CLA)

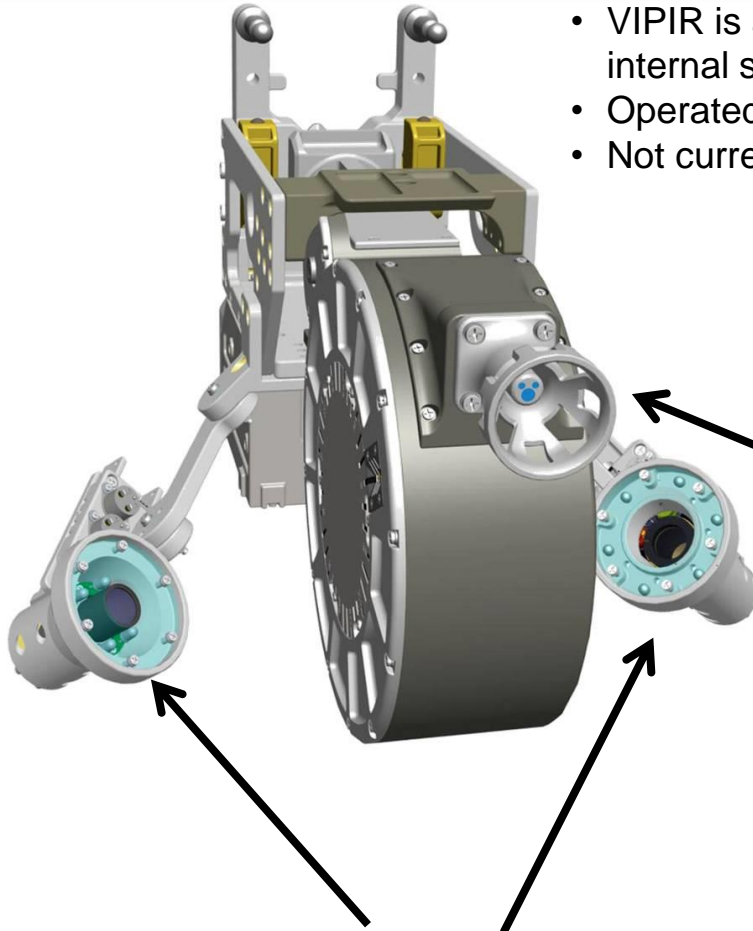
Visual Inspection Poseable Invertebrate Robot (VIPIR)

- Manifested on ATV-5 for the Robotic Refueling Mission demonstration.
- VIPIR is a "boroscope" inspection tool that provides a set of eyes for internal satellite repair jobs.
- Operated through SPDM (DEXTRE)
- Not currently planned for permanent stowage on ISS.

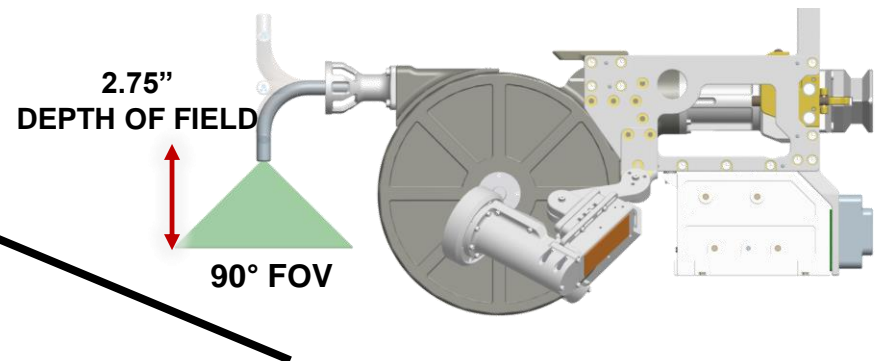
Video Borescope Assembly (VBA)

- Miniaturized Close-range Inspection Camera and light
- NTSC Color Video (224 x 224 pixels)
- 0.93" diameter tube
- 36" maximum deployment - straight line
- Tip manipulation only
- Tip Control, limited monitoring from ground
- Limited to one camera view at a time through SPDM

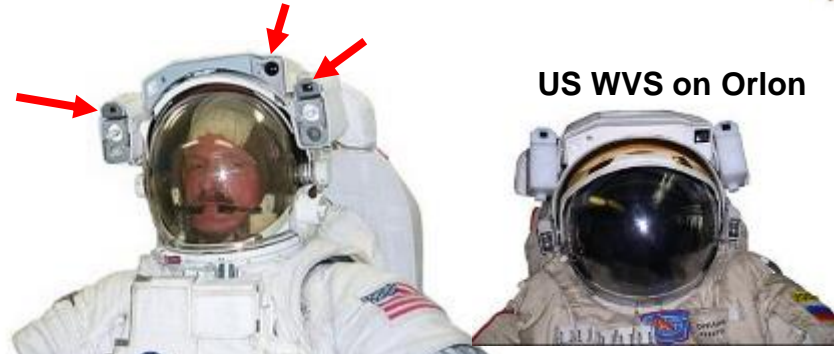
Wireless Video System

- Three SONY XC-999 cameras
- HFOV = 85°, 56° and 30°
- Fixed depth of focus 12 inches to 25 feet.
- Detectable resolution .25-.5 inch at 10 feet.

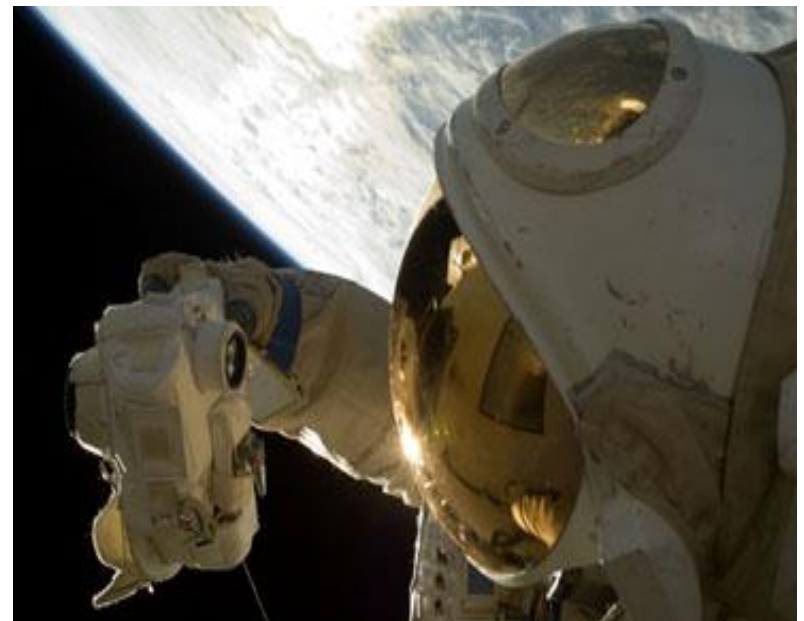
Digital SLR

- Nikon D2XS and soon, D4
- Lens focal lengths 10.5-180mm

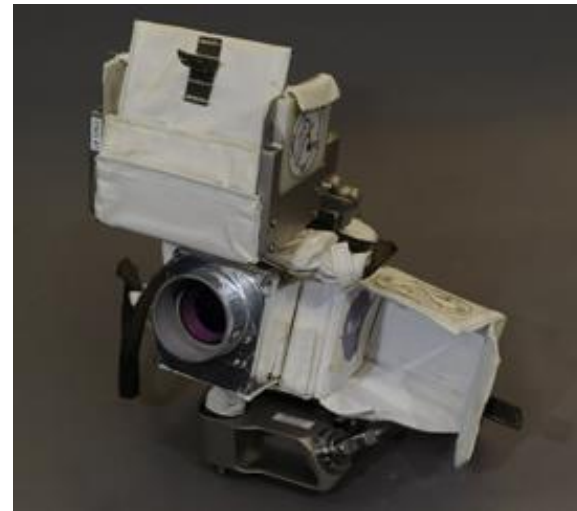
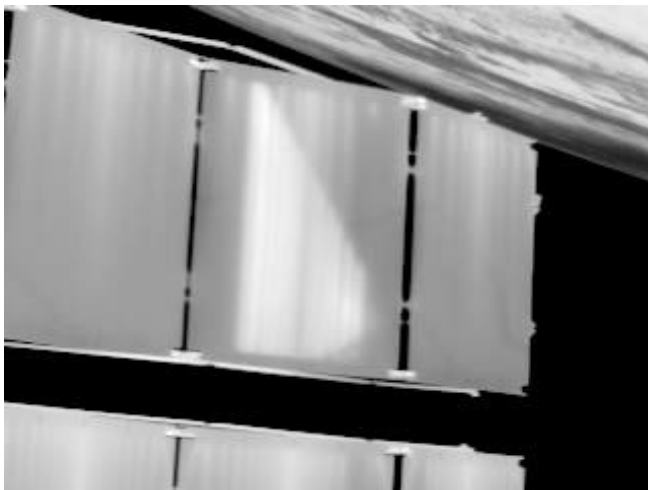
External/Internal IR Camera

Repackaged FLIR Systems ThermaCAM S60 Infrared Camera

Used for inspections of:

- Electrical components
- Radiators
- Solar Arrays
- Heaters

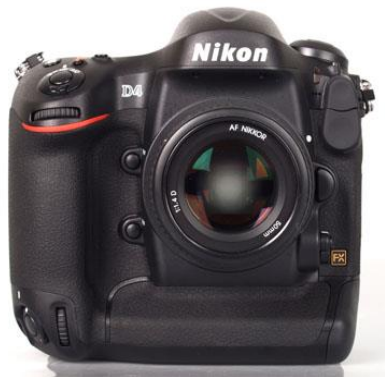
Internal Crew Cameras

- Handheld still cameras provide the highest imaging resolution of any of the existing ISS imaging assets.

- Nikon D2XS, D3S and D4 Digital Still Cameras
- Lenses ranging from 8mm to 1200mm
- One Nikon D3s modified for near IR photography/video

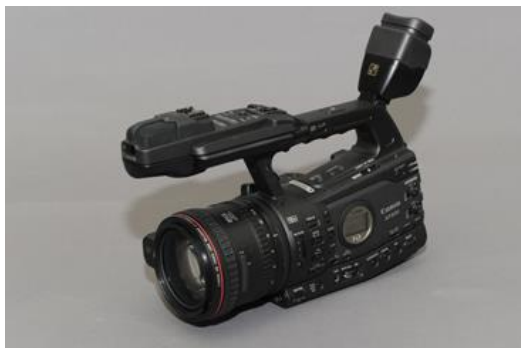
Canon XF305 – mounted and handheld.

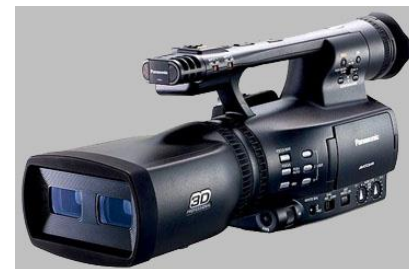
Panasonic 3DA1 – 3D video capability

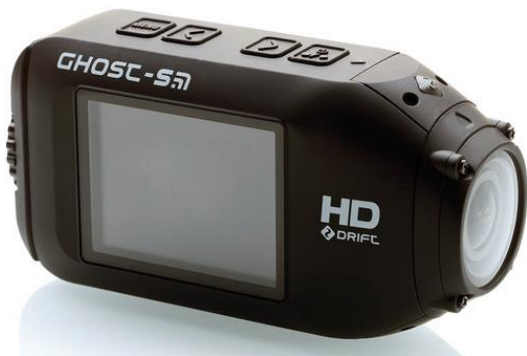
Drift Ghost S Action Camera used for:

- Obtaining HD video in tight spaces
- Over the shoulder views for ground situational awareness.

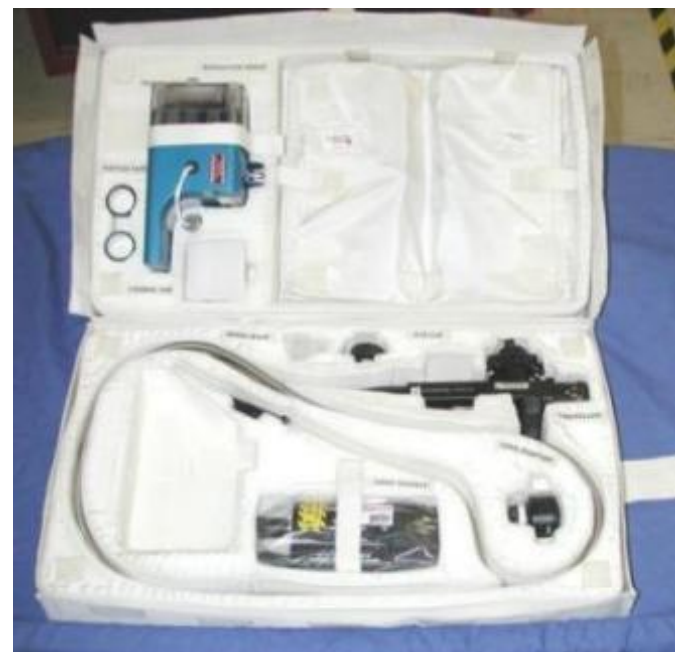
Sony XC-999 Mini-cam

Video camera with fiberscope

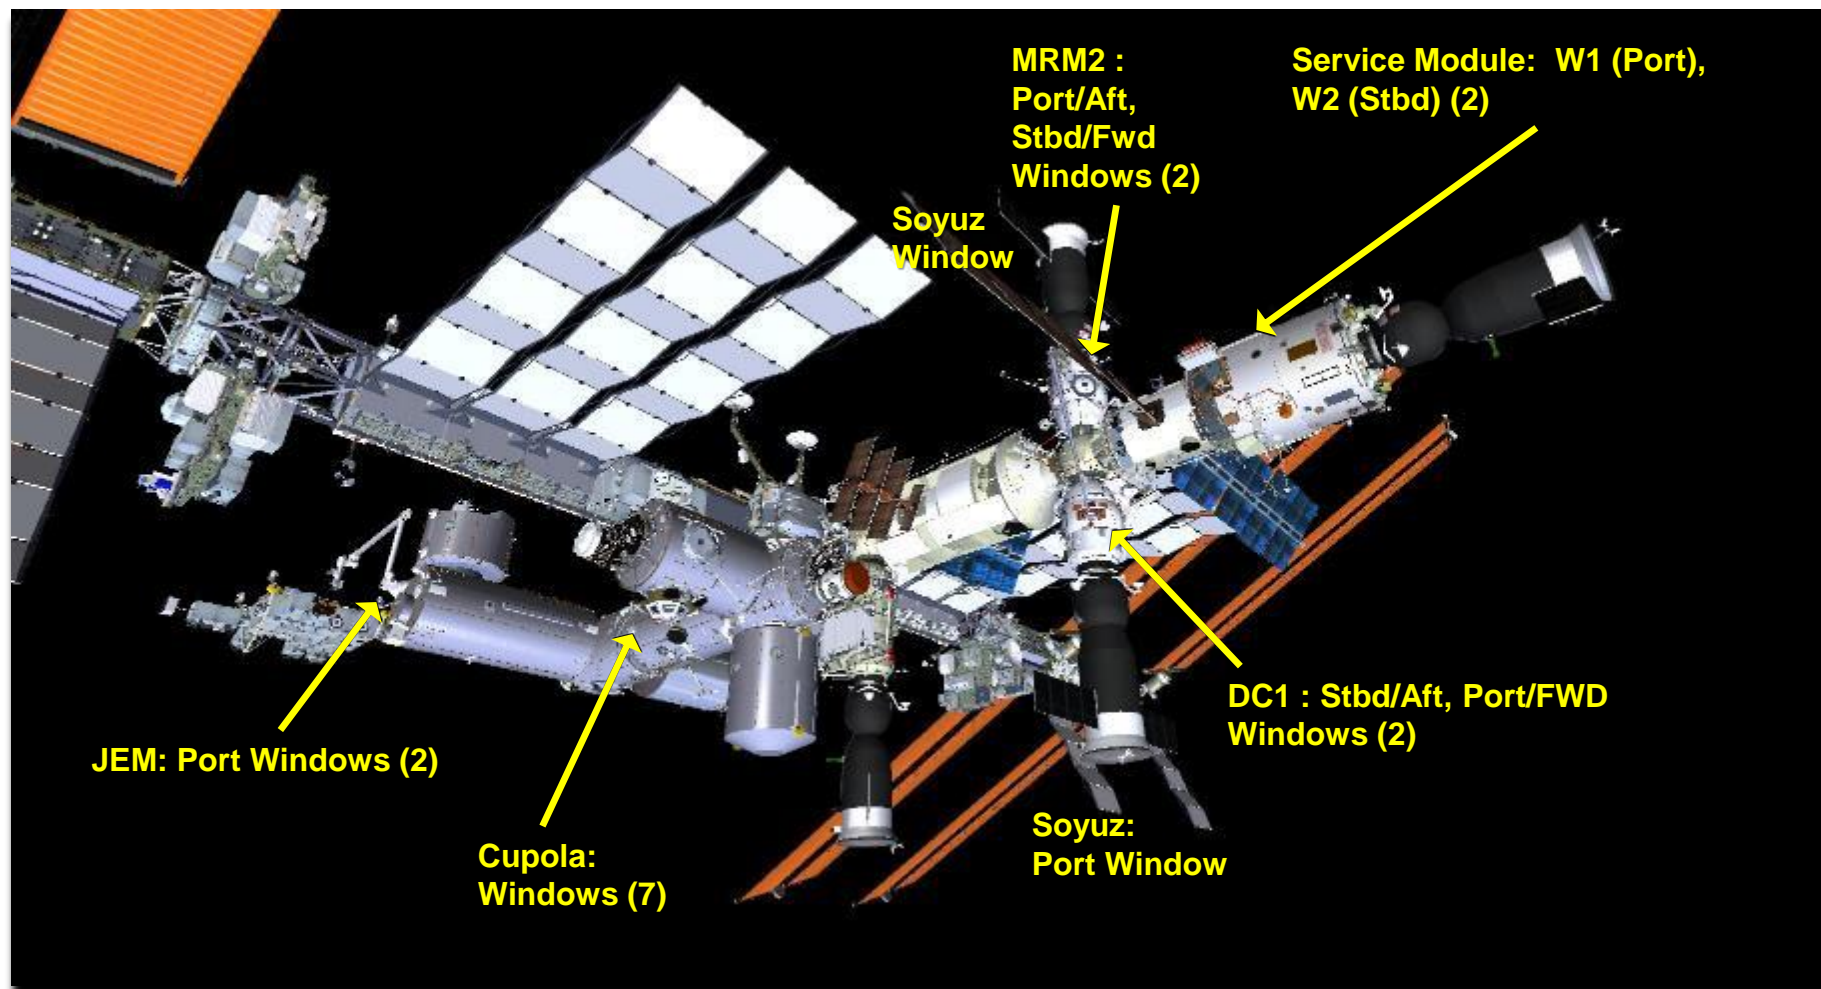
Windows for External Surface Inspection

Russian segment and Cupola windows provide coverage of truss aft surfaces and JEM windows provide coverage of port, forward truss surfaces not visible in ETVCG blind spots.

Not all windows are referenced

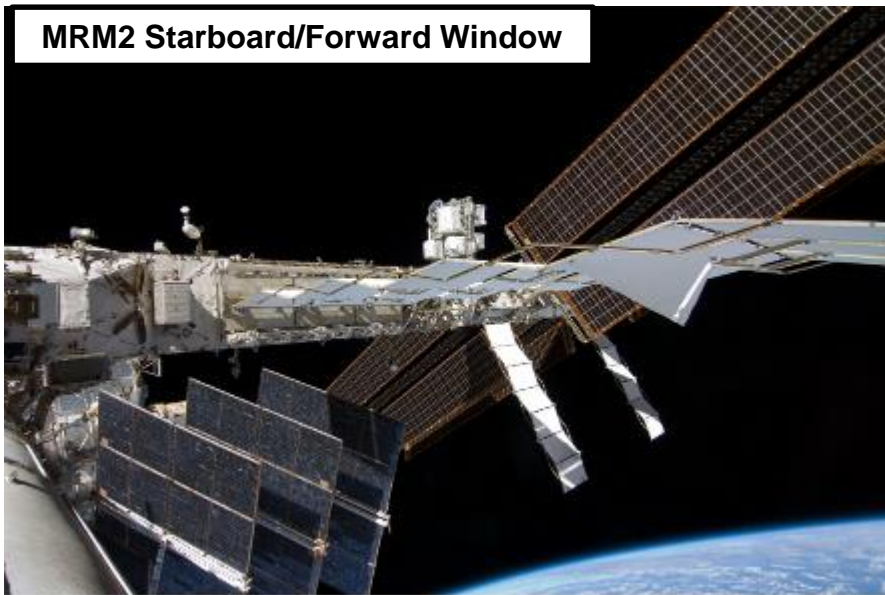
MRM2 Starboard/Forward Window

S129E007742

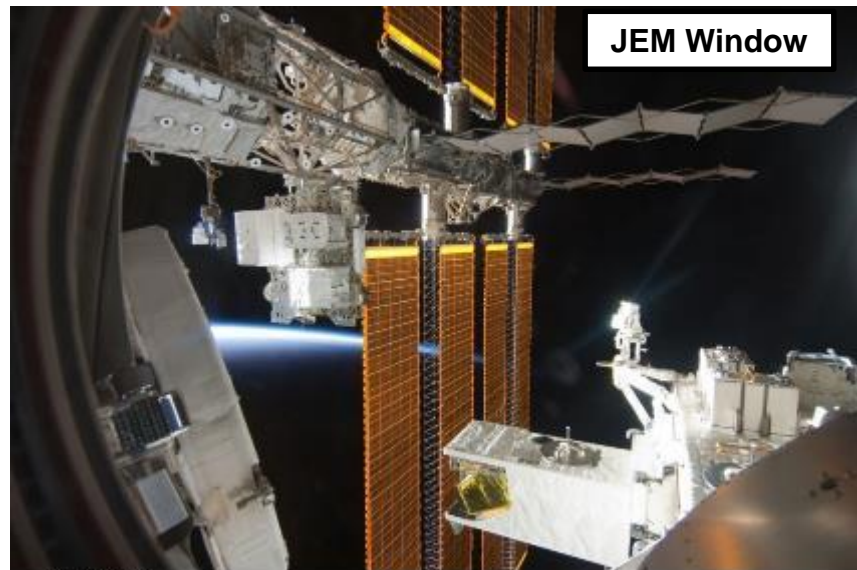
JEM Window

S133E008894

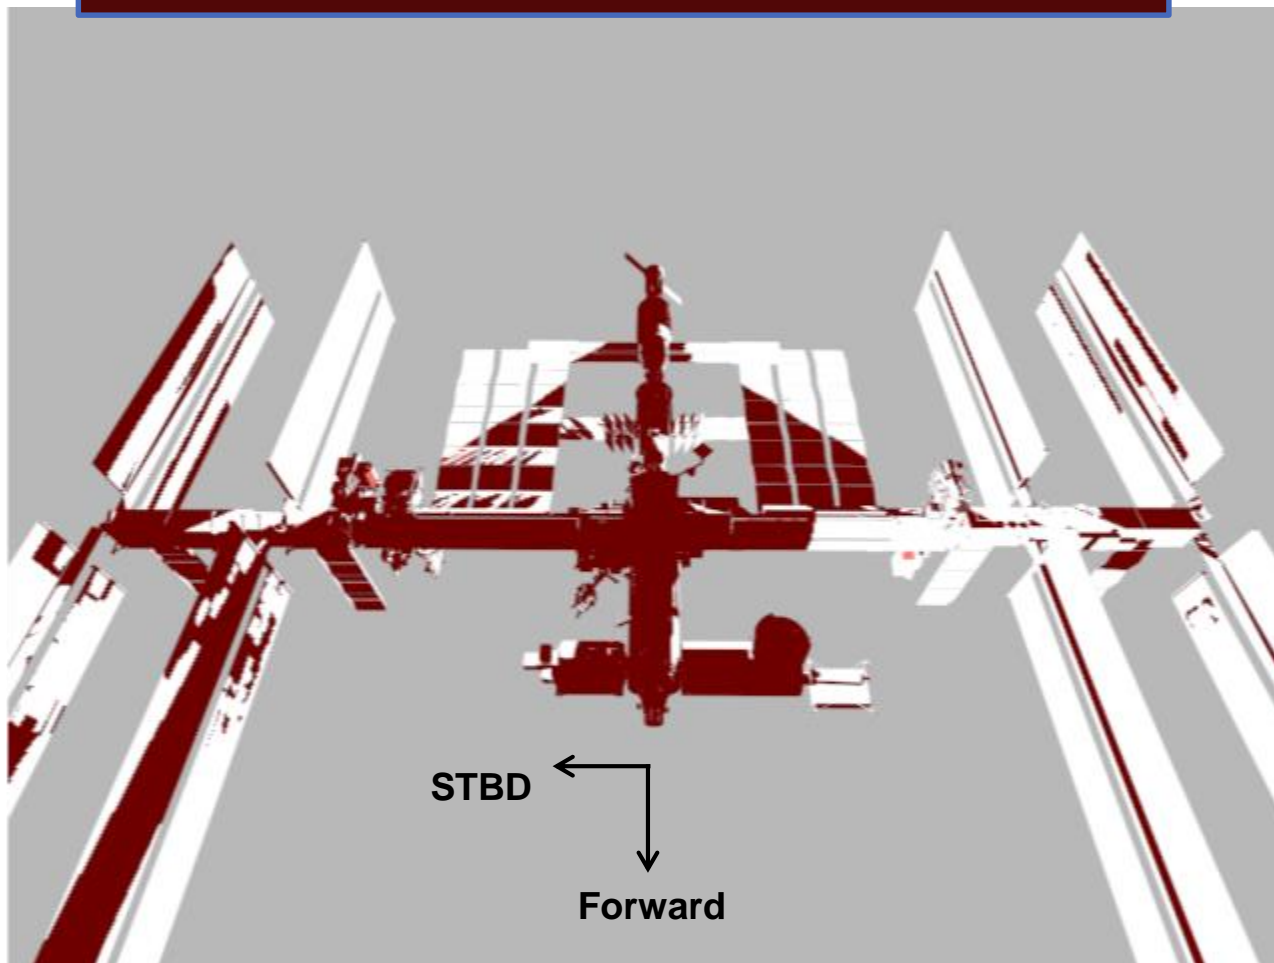
Viewing from above

Brown shading shows window “blind spots”

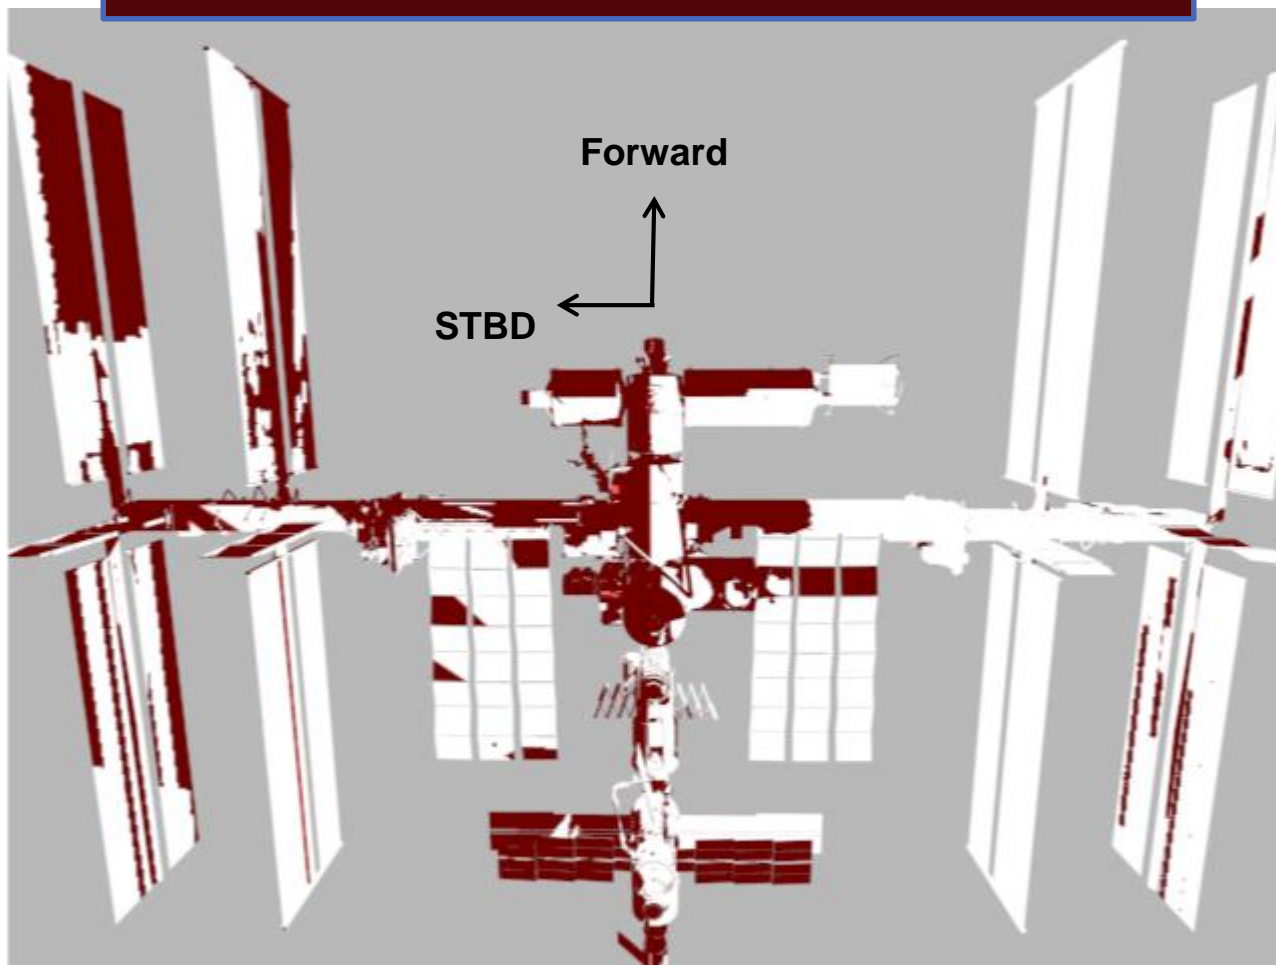
Viewing from below

Brown shading shows window “blind spots”

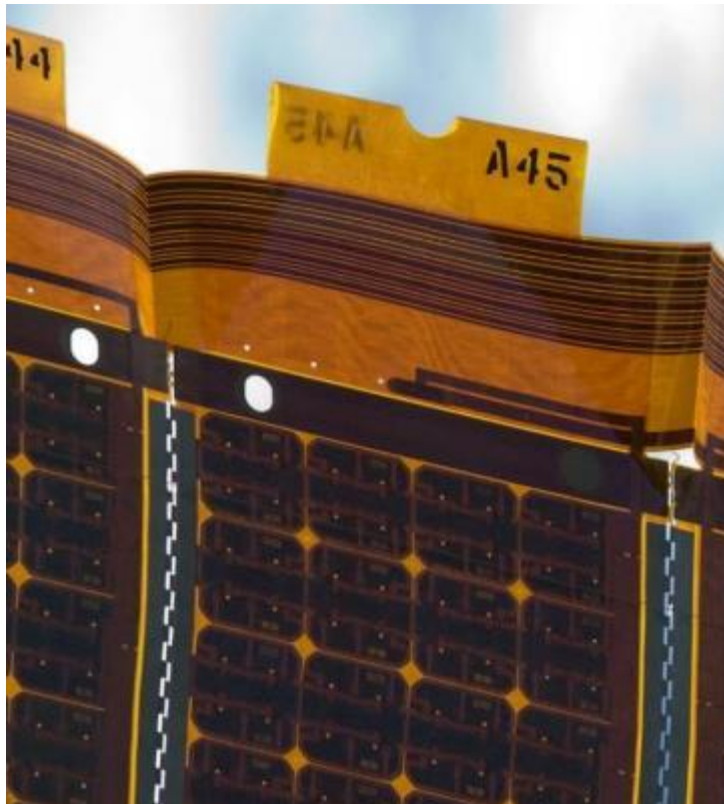
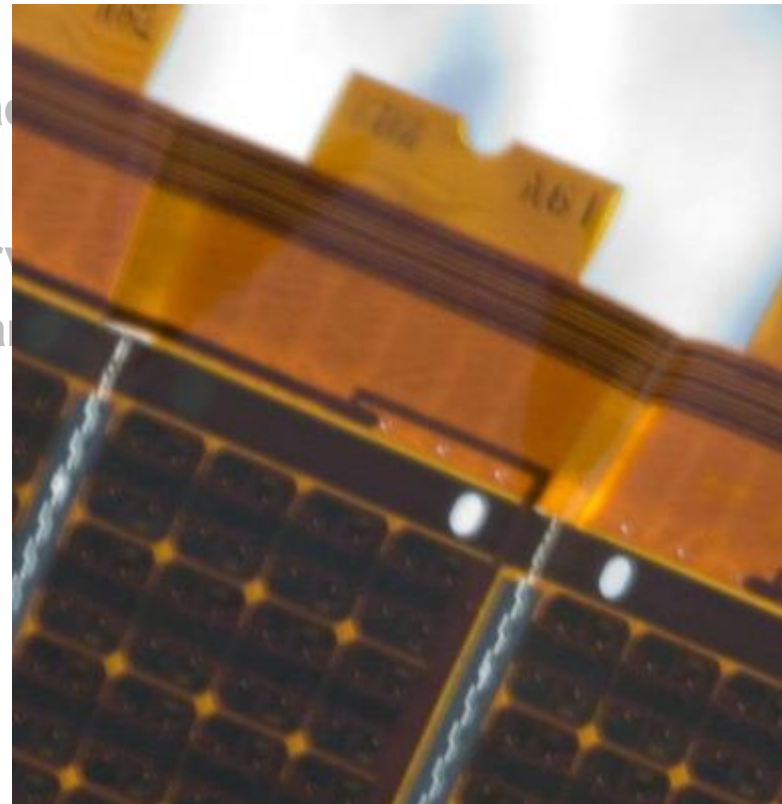
- Limited windows, numerous blindspots
 - Distance and high incidence viewing
- **Protective plastic scratch panes installed over Cupola and JEM windows reduce image resolution but need justification for removal and the removal and reinstallation process is time consuming (Cupola 1-4 hours).**

Out of focus appearance is due to wave front interference caused by shooting the photo though the scratch pane.

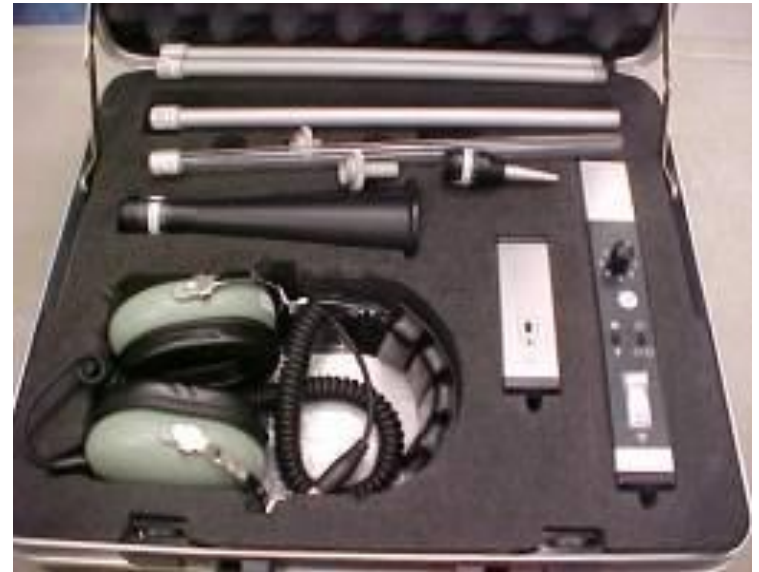
- Handheld Ultrasonic leak detector
- Ammonia Mass spectrometer

- Challenges for Internal Inspection:
 - Stowage can be in the way
 - Crew time to rotate racks can be hours
 - Some issues (e.g. module leak) could reduce risk(time) with better IVA tools:
 - Improve Ultrasonic Leak Detector adapters
 - Full-length Controllable Stereo View Endoscopes
 - Access NDE inspection after leak plug has been installed

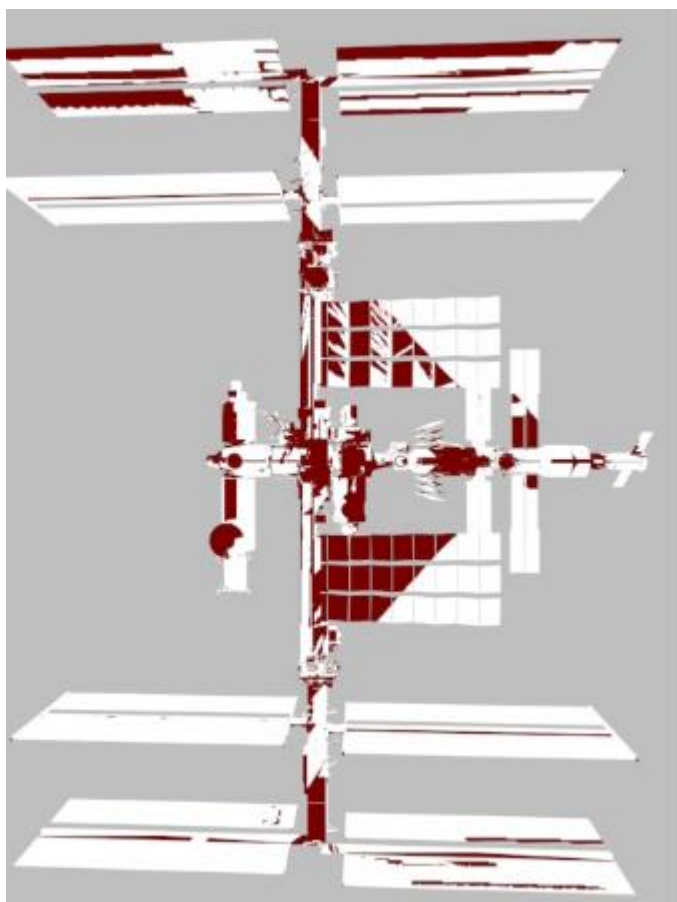
Viewing from above

Brown shading shows window “blind spots”
